APPLICATION FOR FINANCIAL ASSISTANCE
Revised 4/99

PROJECT NAME: Westgate & Scott Street Reconstruction

Contained herein are observations, conclusions and recommendations concerning pavement and subgrade conditions along Westgate Drive, extending from East Morgan Street to Western Ridge Drive within the Village of Cleves, Ohio. This work was performed in accordance with our Proposal-Agreement N23134-R dated April 14, 2005.

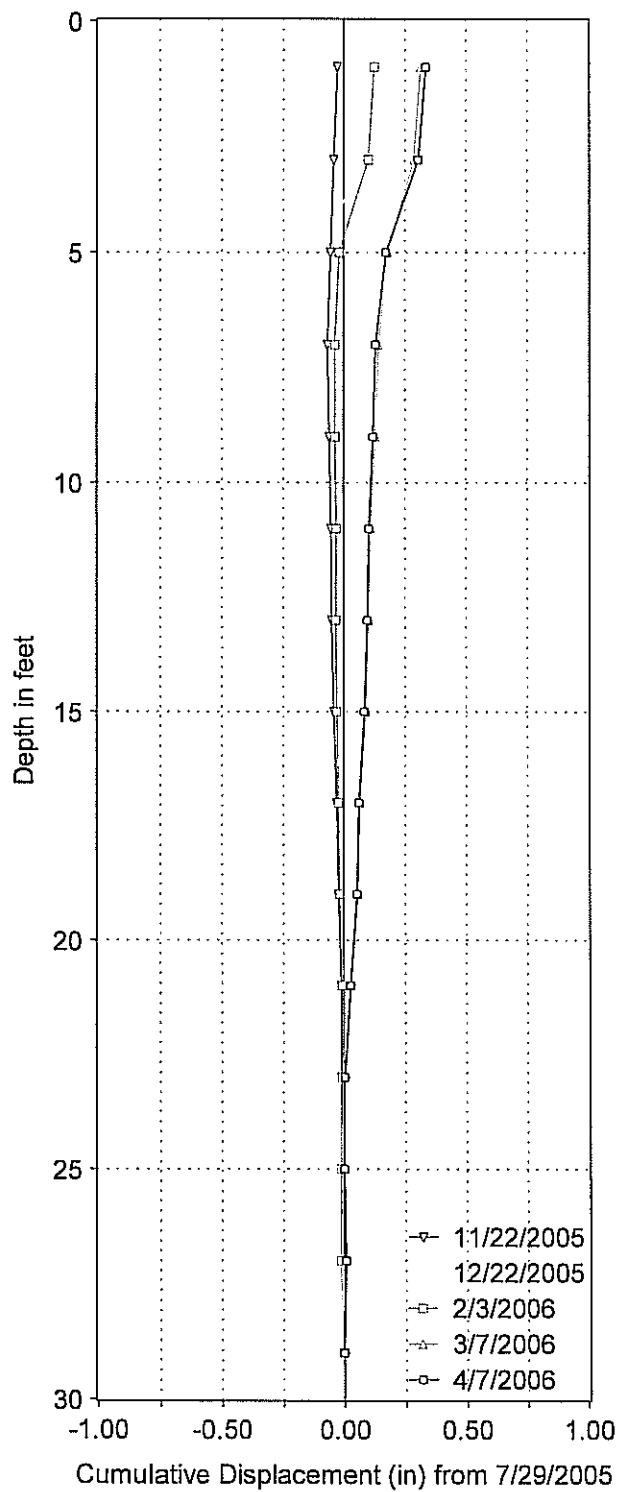
050439 ICM102, A-Axis
North (+) and South (-)

Readings taken subsequent to February 2006 in Test Boring 102 indicate movement in the upper 4 feet of up to 1/2 inch. A second trend noted in the later readings is a creep movement of nearly 1/4 inch, beginning at the surface of the interbedded shale and limestone bedrock, which was encountered at depth of 22.9 feet in the test borings.

We recommend that the creep movement be monitored, via the existing slope inclinometer, on an annual basis to assess the degree of subsurface movement.
